Load test to collapse on the masonry arch bridge at Urnieta

ABSTRACT: This paper presents the previous activities, the development, and the full test on a masonry arch bridge located in Urnieta, Basque Country, Spain. The first task was the estimation of the collapse load by means of several tools developed to analyze this type of structures (commercial and educational software), starting off with real initial data like the geometry, and hypothetical data like material properties (crushing strength masonry), height and nature of the backfill, etc.

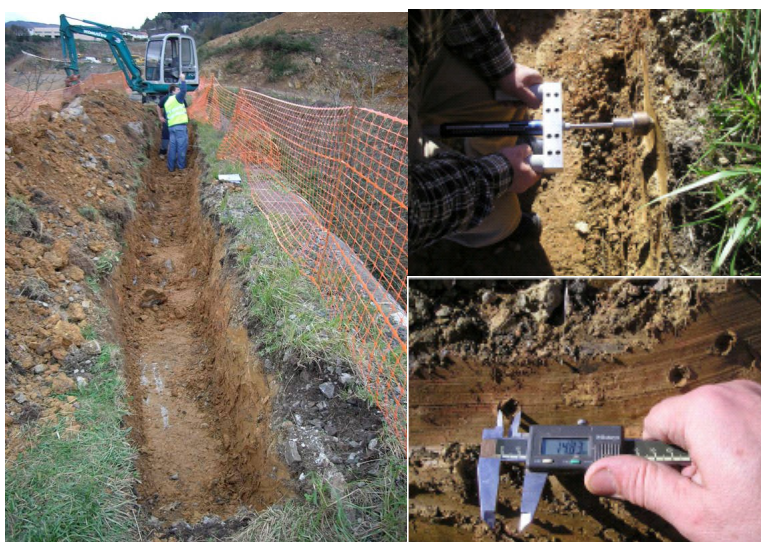
Figure 5: Removal of fill and geotechnical studies

Due to operational reasons, and taking into account that a multi-span failure seemed to be unlikely, it was decided to test the arch adjacent to the abutment (the first from the right side in figure 2). Since the load-bearing capacity of such type of structures is strongly dependant on the height and nature of the backfill, a recognition campaign of these materials was developed on the opposite side of the bridge (on the left side, according to figure 2). Additionally, geotechnical tests were made to determine the resistance of the granular fill to the penetration and to establish their different levels of superficial compaction (figure 5).

Beneath a layer of clay and limestone rubble, a sound concrete made up on cement and lime was observed. This inspection detected a higher top level of the backfill (up to 5.70m), slightly over the arches. As mentioned above, the highest load-bearing capacity of the structure, provided that the load were applied exactly at the extrados of the barrel, gave a theoretical value of P_{ult} equivalent to 7,000kN. The foreseen failure mode was a typical four-hinge mono-arch mechanism. The position of the load leading to the minimal collapse energy was $L/3$, as shown in figures 6 and 7.

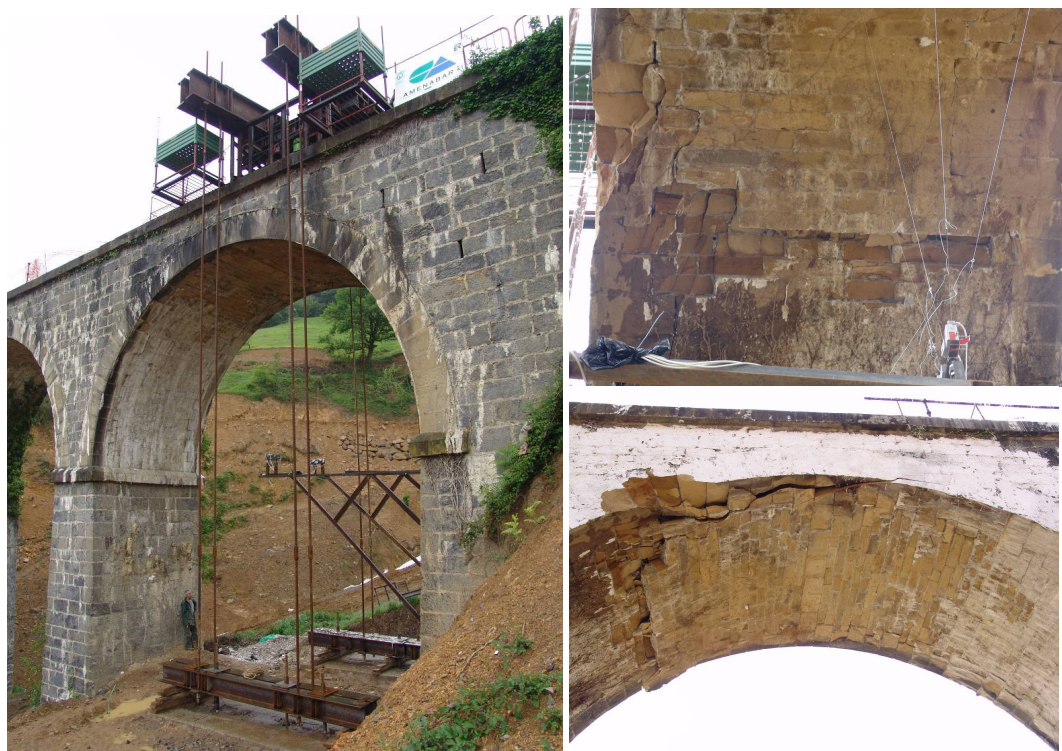
Figure 8: Left: general arrangement during the test. Right: failure mode.

The test itself lasted about four hours. The measured maximum load applied by the jacks was 7,467kN. The detected failure mode was the simultaneous crushing of the voussoirs of the barrel and arch face, immediately beneath the applied load. No hinge or relevant movements were detected. Just at the end, during the last load step, a separation of spandrel walls and some cracks at voussoirs or opening of their joints were detected.

When the applied load reached 7,500kN, a progressive crushing of the barrel, as well as a separation of the spandrel wall and the barrel was detected. The limestone voussoirs collapsed within an area that extended from the point beneath the load line and its symmetric respect to the center of the arch (see figure 8).
